# IAEA Nuclear Energy Series

No. NF-T-2.1

## Review of Fuel Failures in Water Cooled Reactors

Review of fuel failures in water cooled reactors. — Vienna : International Atomic Energy Agency, 2010.

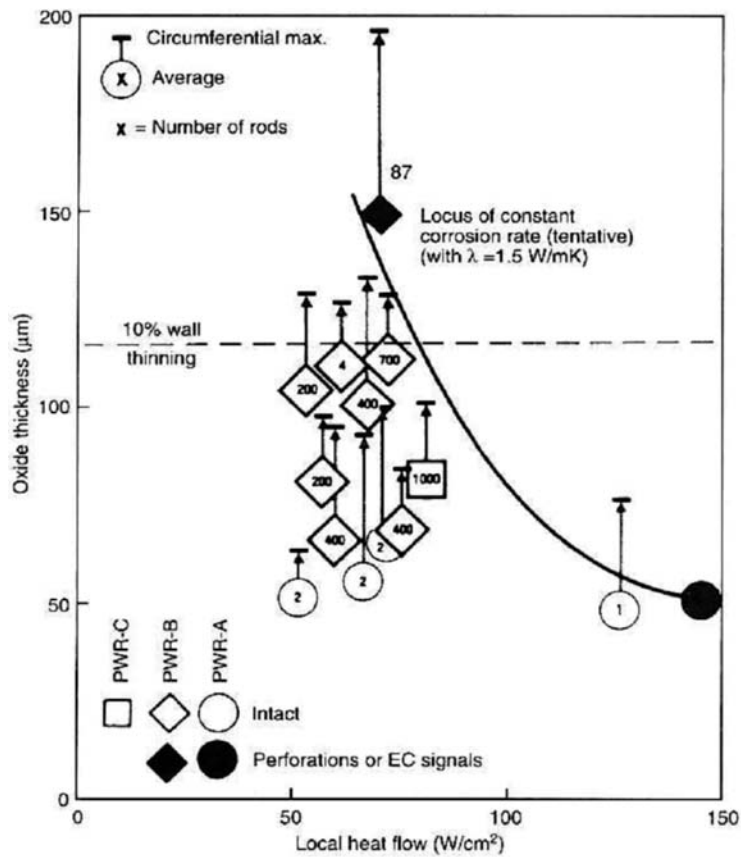
FIG. 5.19. Relation between corrosion defect, oxide thickness and local heat flow [5.34].

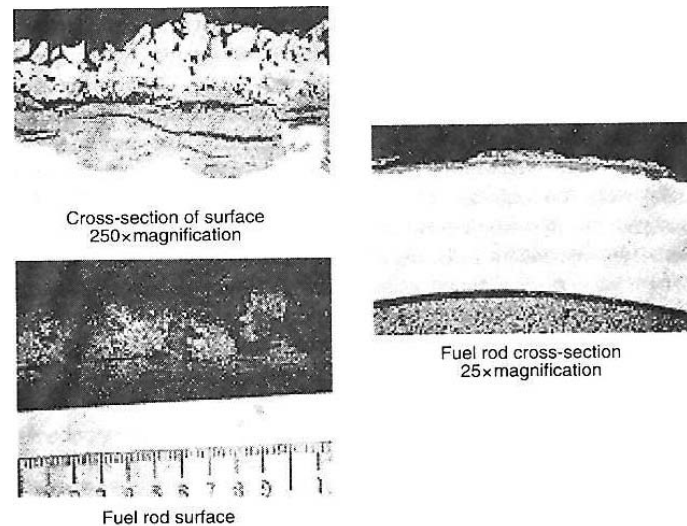
FIG. 5.20. Crud and oxide (formally nodular) on CILC damaged fuel rod [5.39].

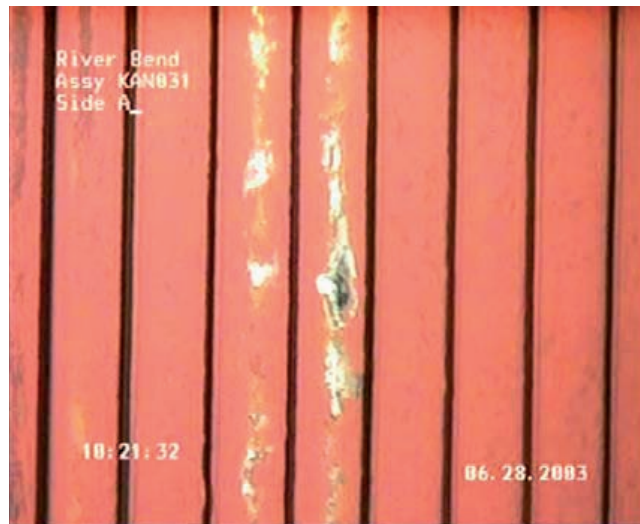
FIG. 5.22. Failure location noted from bubbles escaping at a defect in a peripheral rod [5.43].

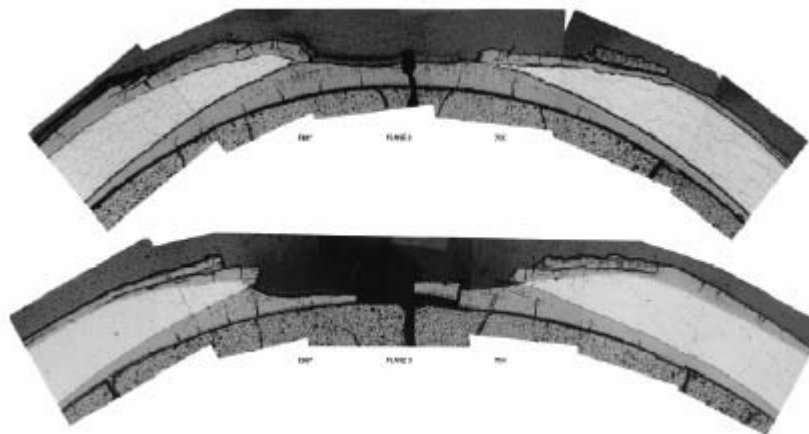
FIG. 5.26. TMI 1, Cladding corrosion on a rod O11 at an elevation of 118.5 inches [5.46].

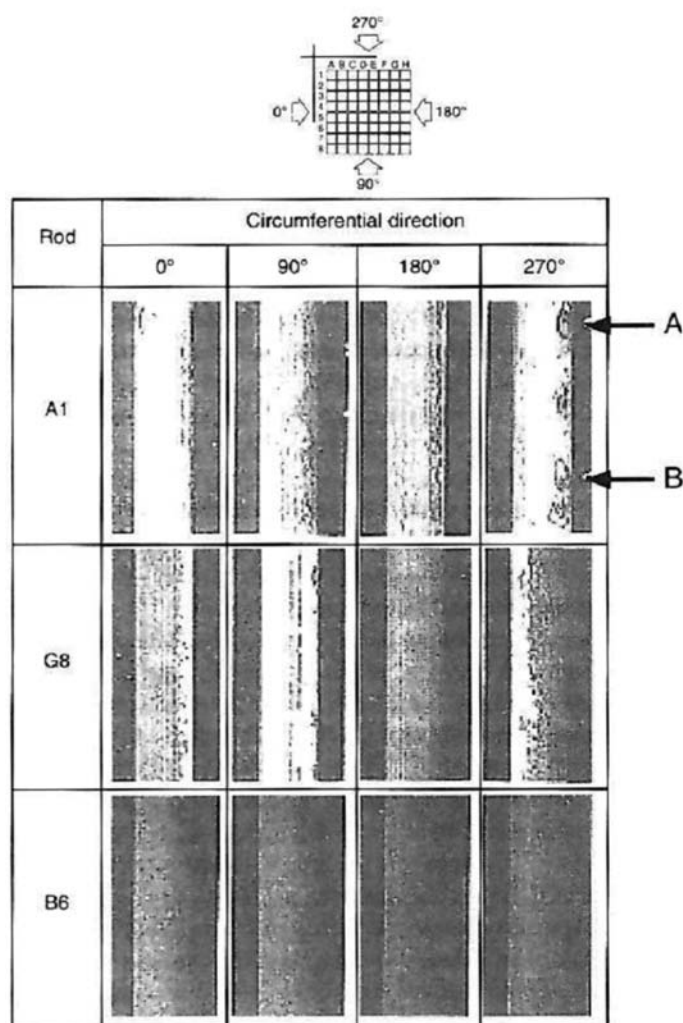
FIG. 5.27. Typical appearances of failed Hamaoka 1 rods 'A' and 'B' showing primary defect locations [5.41].

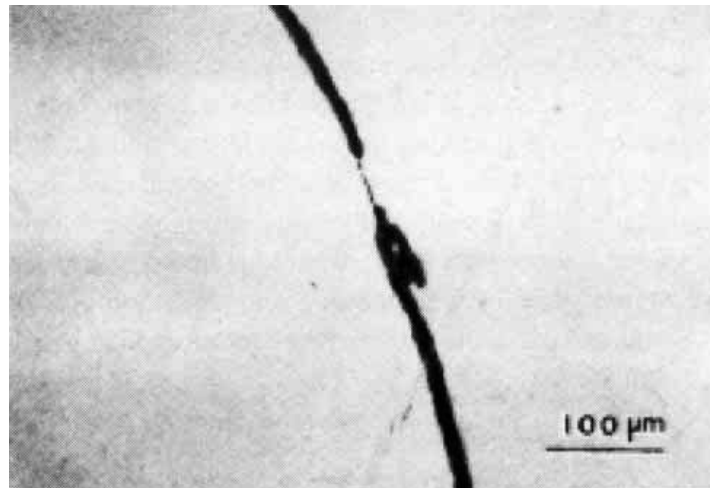
FIG. 5.42. Typical leak path due to incomplete cladding at the end cap weld [5.93].

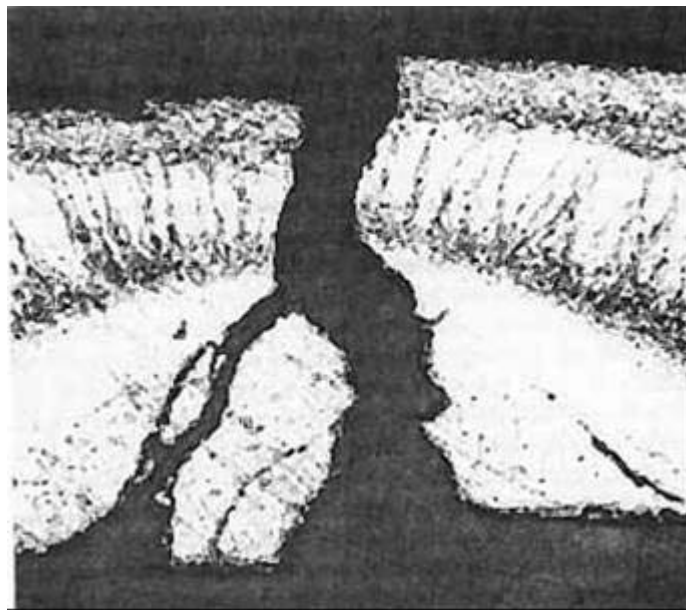
FIG. 5.44. External heavy local hydriding and crack due to Ni contamination of the cladding surface [5.96].

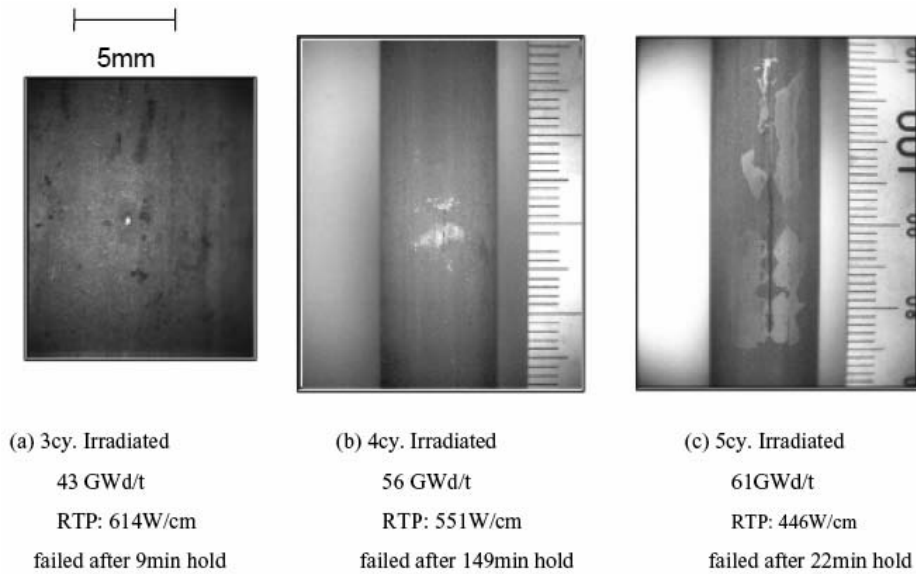
FIG. 5.49. Visual appearance of failed segment rods.

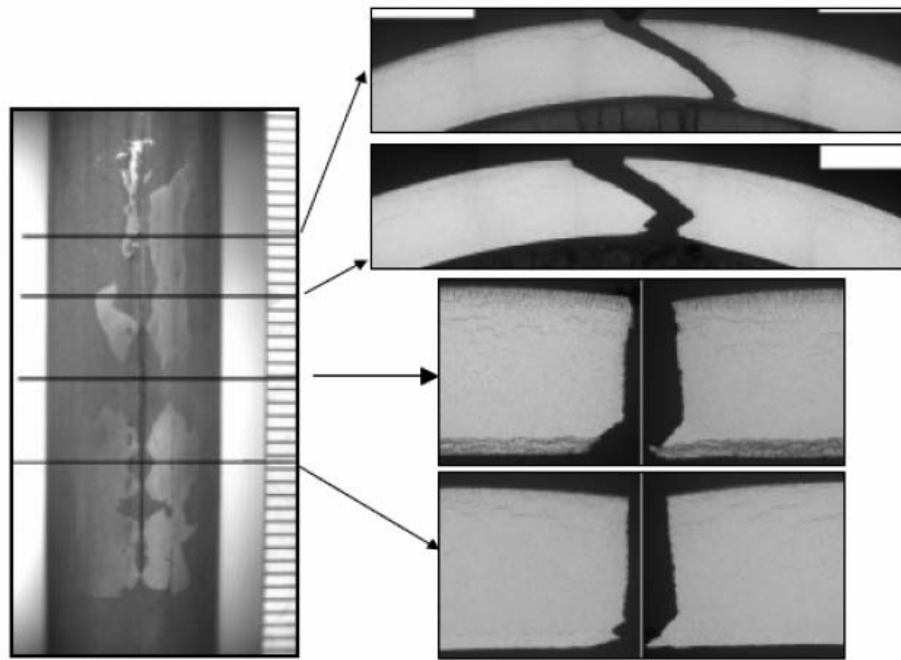
FIG. 5.50. Visual appearance and cross-sectional metallography of a failed segment rod (irradiated five cycles, RTP: 446 W/cm, failed after 22 min hold).

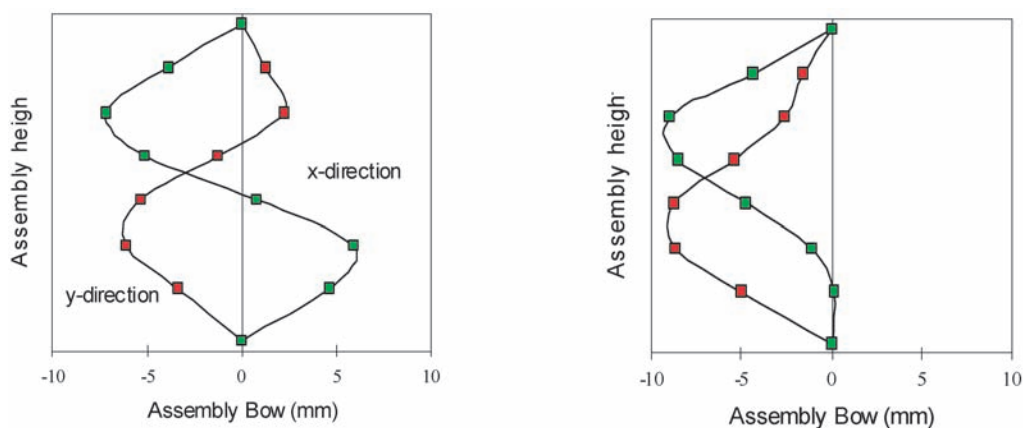
FIG. 6.1. Ringhals 3 — example of S-shaped and C-shaped assembly bows [6.5].

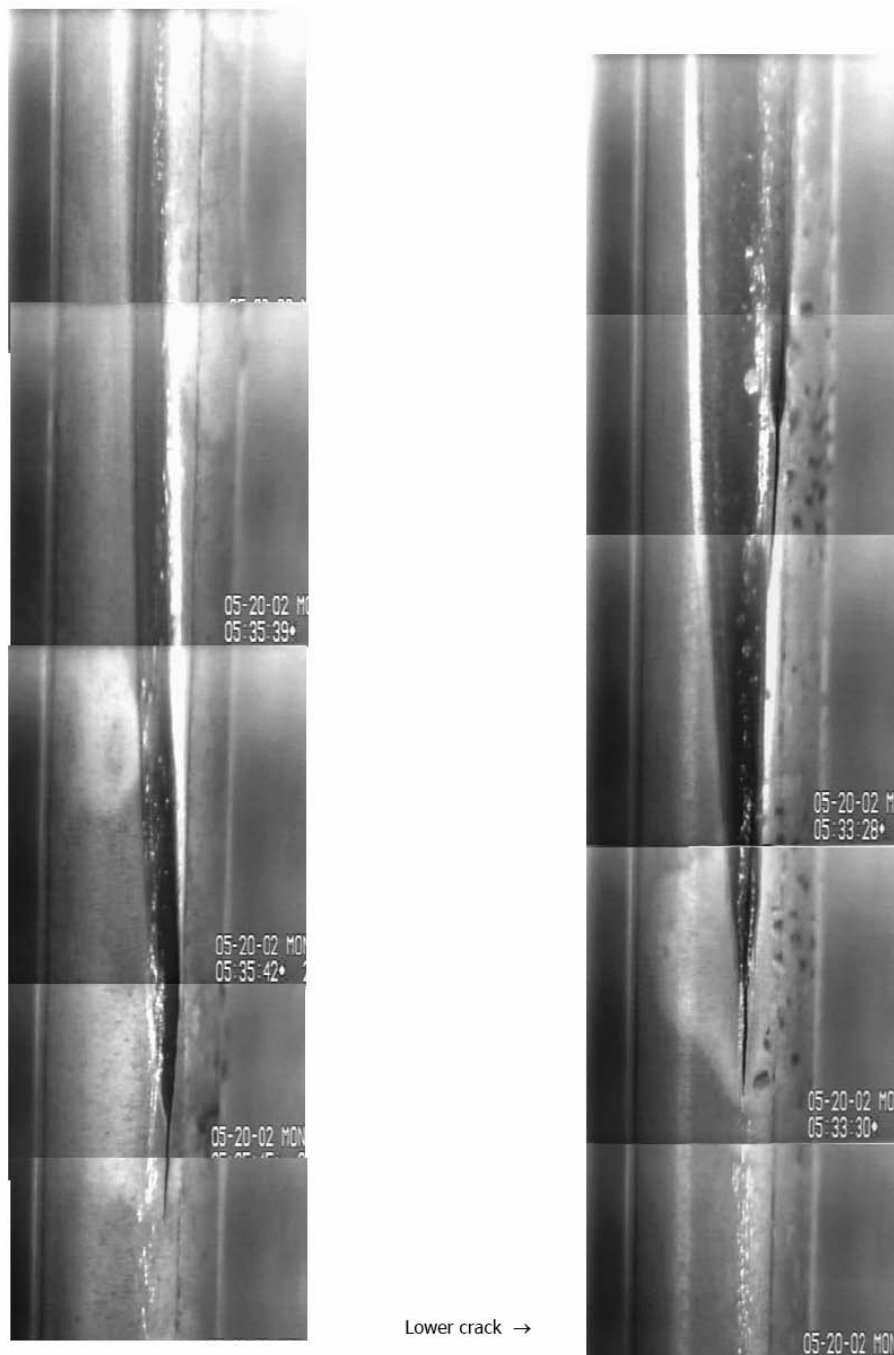
FIG. 7.3. Example of an axial split failure in a PWR fuel rod [7.12].

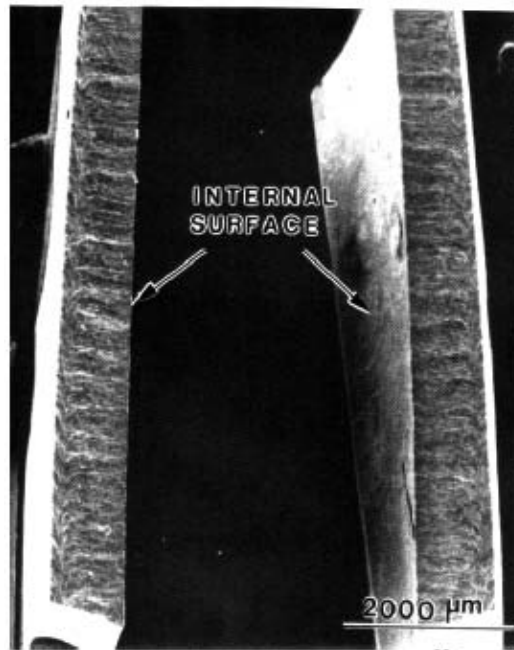
FIG. 7.13. SEM fractography of a split [7.28].

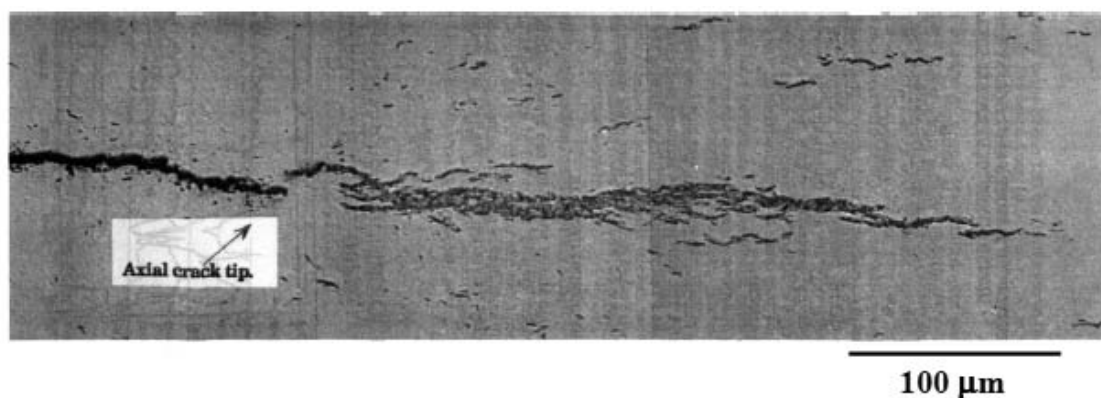
FIG. 7.16. Metallography at the crack tip reveals precipitated hydrides [7.21].
