# IAEA Nuclear Energy Series

No. NF-T-2.1

## Review of Fuel Failures in Water Cooled Reactors

Review of fuel failures in water cooled reactors. — Vienna : International Atomic Energy Agency, 2010.

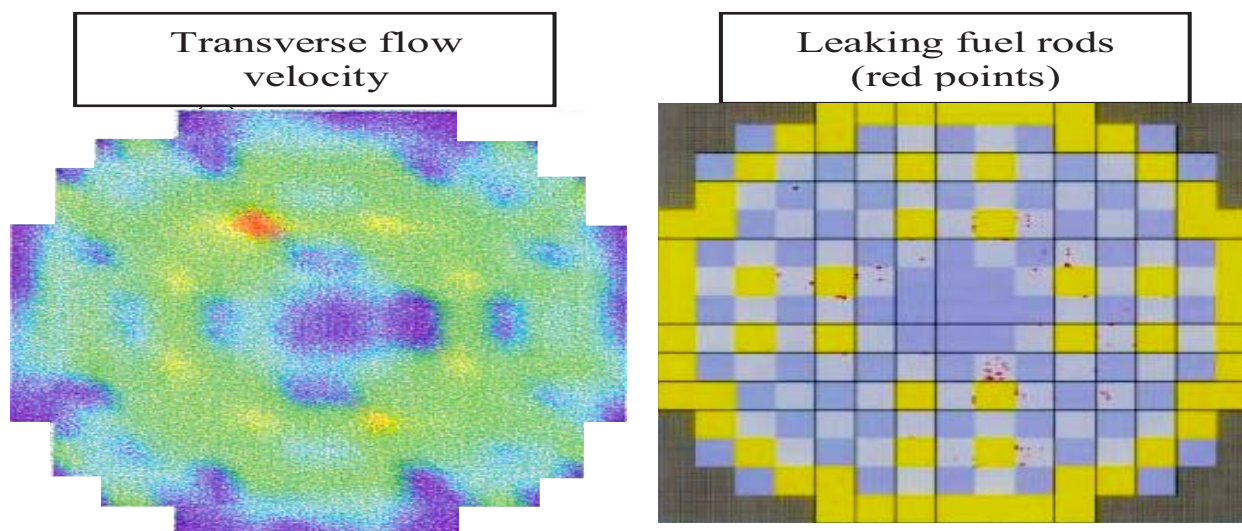
FIG. 5.2. Comparison between cross-flow computation (a) and leaking rod locations due to grid to rod fretting (b) on EDF 1300 MWe core [5.14].

Unexpected excessive flow induced vibration may occur at certain locations with severe flow conditions in the reactor core. Calculations of flow distribution at the bottom of the reactor vessel and within assemblies (axial and cross-flow), performed in the case of Cattenom 3, showed that higher cross-flows (red and yellow areas in Fig. 5.2) were distributed in an intermediate ring around the core. This correlated strongly with failed fuel assembly locations [5.14].

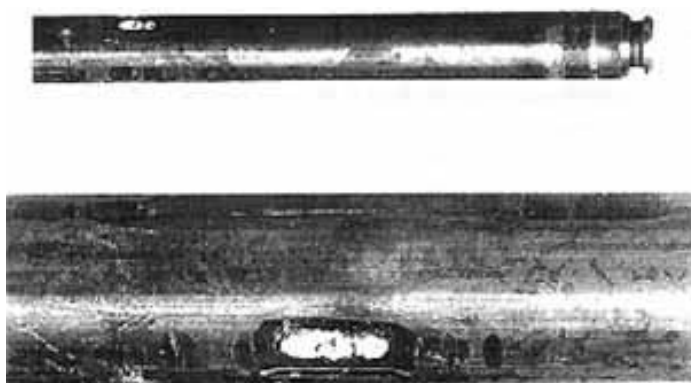
FIG. 5.4. Fretting defect induced by grid to cladding interaction [5.18].

Other cases of fretting failure due to spacer fabrication were also related. Fretting defects were observed in two Framema fuel assemblies [5.18]. A defect is shown in Fig. 5.4 [5.18]. A very extensive programme of investigation was performed on the fuel assemblies containing the two affected rods, yielding detailed grid cell dimension information. The results of dimension measurements on the bottom grid cells show very little difference between cells in which fuel rods were securely held and the two cells where fretting corrosion took place. In both fuel assemblies, the defect occurrence is estimated to take place either at the end of the second irradiation cycle or during the third cycle. The conditions for such a defect occurrence might plausibly be a combination of: (a) specific transverse flow at the bottom end grid; and (b) initial grid cell characteristics in excess of specification values, leading to excessive relaxation of the restraining force.

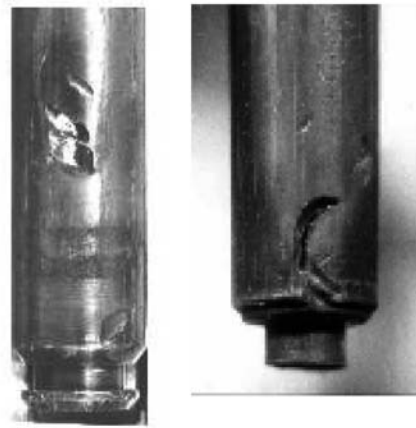
Loose metallic debris can circulate in the reactor system and become trapped in the fuel assembly. Typically, debris is trapped between fuel rods and a spacer, usually the bottom one, and less frequently in spacers higher up in the assembly. The debris particle vibrates under influence of the coolant flow and causes fretting erosion of the cladding [5.28, 5.29]. The typical appearance of debris defects is shown in Fig. 5.12.

FIG. 5.12. Example of debris fretting failures at bottom fuel rod.

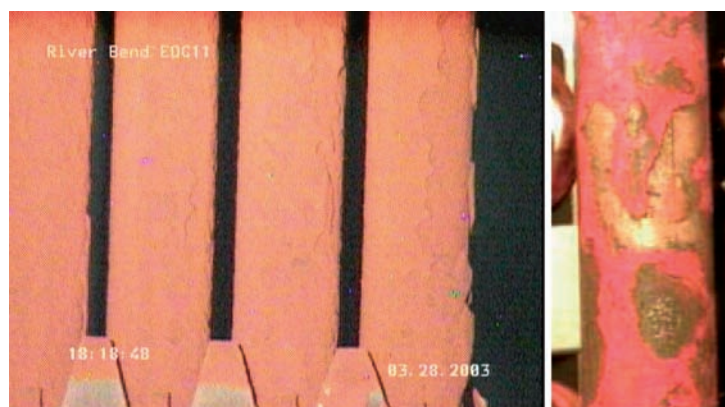
The majority of other failures were localized in Browns Ferry Unit 2 where, during cycle 12, which operated from April 2001 to March 2003, 63 GE13 fuel assemblies in their second cycles of operation had fuel rods that failed from accelerated corrosion [5.44]. The entire second cycle reload, first loaded in May 1999, exhibited accelerated corrosion peaking towards the top of the bundle. The first and third cycle bundles operating in the same cycle, as well as previously discharged fuel in the fuel pool, were normal, well inside GNF's experience base. Despite a significant effort, including detailed reviews of reactor water chemistry, fuel manufacture and fuel operation, no root cause of the fuel corrosion failure at Browns Ferry has been determined. It is likely that a combination of conditions existed which resulted in the fuel failure. The combined failures at Units 2 and 3, and their timing, seem to indicate an unusually aggressive water chemistry condition, perhaps related, during or immediately after one or both of the affected reloads' first cycle of operation. Cladding material which was lower in alloy content and higher in duty was most affected by this environment. A hot cell exam to provide further insight is in progress.

FIG. 5.21. Example of heavy crud in lower Span 2 before and after brushing [5.43].

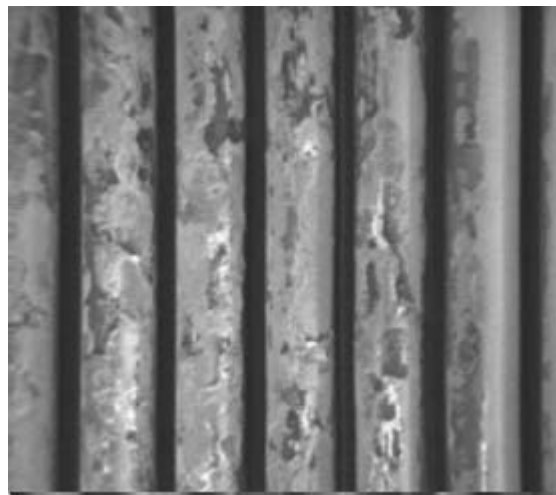
FIG. 5.23. Distinctive crud pattern (DCP) in TMI fuel assemblies [5.46].

Enhanced clad corrosion due to crud deposit was also reported in a few US PWR plants between 1995 and 2000. In particular, during cycle 10 in 1995, TMI-1 experienced nine failed rods owing to unusual buildup of corrosion products in the upper spans on the outer surface of peripheral fuel rods [5.45]. This crud buildup and the following fuel failures occurred in the first cycle with highly enriched fuel of 4.75% (in a 24 month cycle). The distinctive crud pattern (DCP) of the failed rod was characterized by a mottled appearance, specifically a dark, nearly black surface with jagged patches of white showing through and occurring around 2.8 metres from the bottom of the fuel rod as shown in Fig. 5.23.

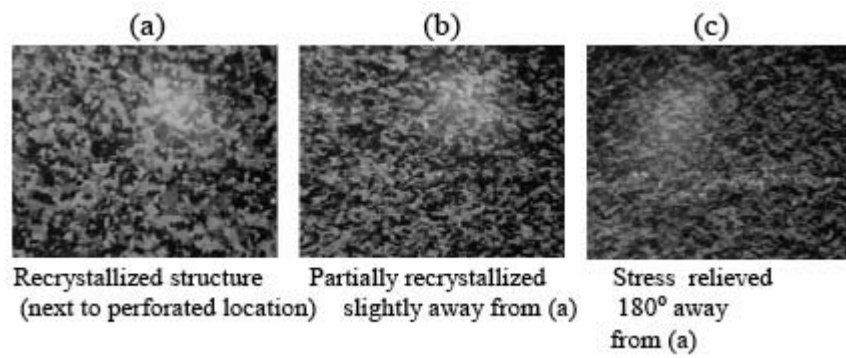
Poolside and hot cell investigations to delineate the cause of fuel failures were performed [5.46]. Results indicated greater corrosion and hydrogen pickup than predicted in the upper spans, regions of cladding recrystallization in areas of unusual crud pattern as shown in Fig. 5.24, and hydrogen migration away from those areas. These observations indicated that higher than expected temperatures occurred in DCP areas. Cladding oxidation and hydrogen pickup were also higher than predicted at the elevation of DCP regions on rods, consistent with high cladding temperatures.

FIG. 5.24. Grain structure of the zircaloy cladding [5.46].

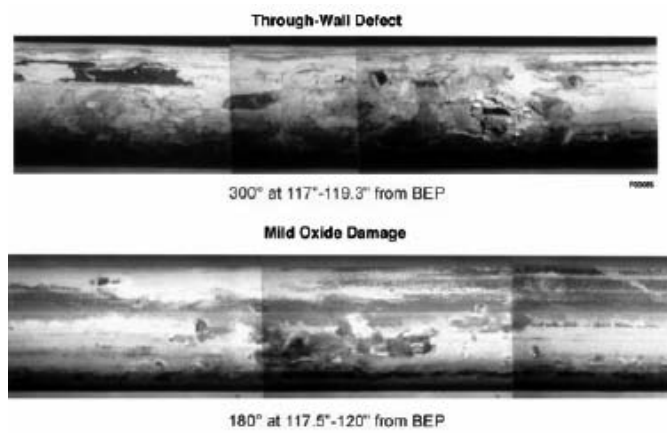
Localized cladding penetration due to crud induced localized corrosion was identified as the failure mechanism, see Figs 5.25 and 5.26. Evaluations attributed the problem to a combination of high temperature due to higher power and some flux tilt with fresh assemblies, and a low pH value because of the applied high level of boron poison used to transition from 18 month to 24 month cycles [5.46, 5.47].

FIG. 5.25. TMI 1, Through-wall defect on a rod O11 [5.46].

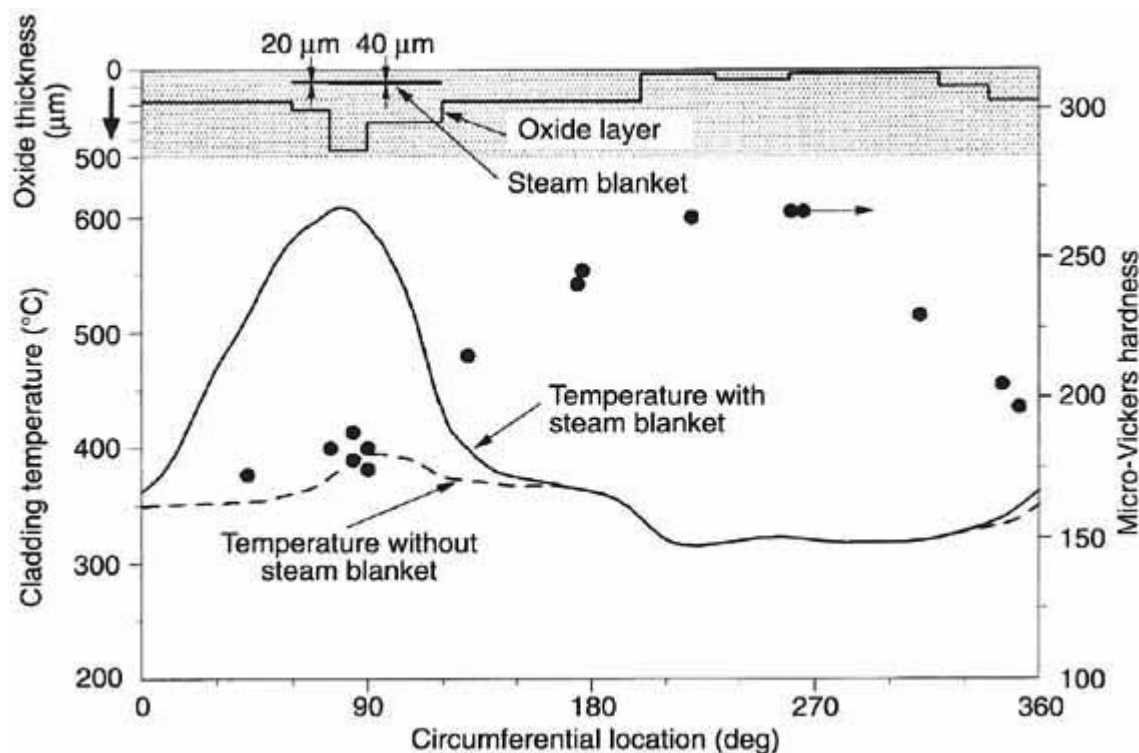
FIG. 5.28. Results of model calculation of the cladding temperature, taking into account oxide effects, with and without the steam blanket [5.41]. (I — hardness)

As stated above, gaps were observed in the thick oxide. When these gaps formed a steam blanket, the cladding temperature may have been enhanced. Figure 5.28 shows a circumferential cladding temperature profile calculated with a model that utilizes measured oxide thickness, together with measured radial cladding hardness distribution. Without the steam blanket effect, maximum cladding temperature was around 400°C, which was not enough to cause recovery of irradiation hardening. However, on the assumption of a steam blanket thickness of 40 mm, maximum temperature increased to around 600°C, which was consistent with the observed hardness recovery. The zircaloy corrosion rate was high enough at such high temperatures to penetrate the cladding wall.

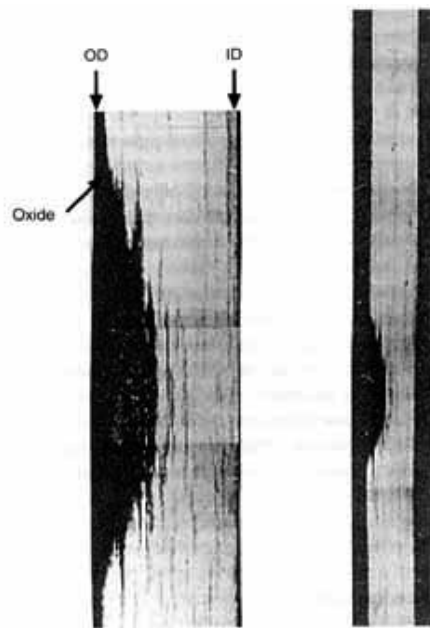
FIG. 5.29. Area of localized hydriding at axial position associated with a gap in the fuel column [5.42].

In a hot cell examination programme, jointly sponsored by EPRI and a utility owners group, ultrasonic examination of fuel rods indicated failed rods to be predominantly located near the central instrument tube, suggesting a power dependent failure mechanism [5.42]. When eddy current examination of neighbouring sound rods showed indications of incipient defects, these rods were sent to a hot cell laboratory for further examination. Hot cell examination of the sound rods revealed highly localized oxidation and hydriding at axial positions, corresponding to the regions of highest cladding temperature. Extensive hydriding was concentrated in areas associated with gaps in the fuel column as shown in Fig. 5.29. Such areas act as a sink for hydrogen. The source of hydrogen is believed to be cladding corrosion. These results indicate that local concentration of corrosion hydrogen is a potential cause of failure at high burnup.

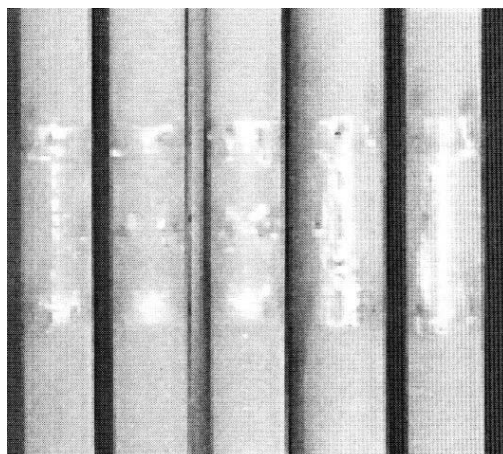
FIG. 5.30. Accelerated corrosion under an Inconel spacer grid [5.54].

However, in 1997, several fuel failures due to accelerated corrosion under Inconel spacer grids were observed in Leibstadt, a BWR in Switzerland [5.53]. Unexpected extensive corrosion of the rod cladding under grid was found during routine inspection on four and five cycle ABB fuel assemblies. Figure 5.30 illustrates the general corrosion enhancement under the Inconel spacers [5.54].

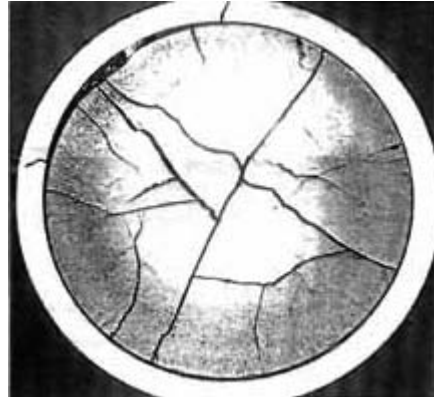
FIG. 5.35. PCI failure due to a wedge shaped pellet chip lodging between pellet and cladding [5.66].

In Gundremmingen B,  $9 \times 9$  fuel rod failure was found to be a result of the presence of fuel fragments in the gap between pellet and cladding, as shown in Fig. 5.35 [5.66]. The metallographic cross-section indicated that the chips are wedge shaped, and originating from the pellet end face, which slid into the gap during operation. In contrast to the usual finding of one crack, this had led to two local brittle fractures in the cladding at an angle of about  $80^\circ$ . It was pointed out that the fuel had been fabricated before current standard practices were applied, which include improved pellet quality, introduction of new end face geometry, improved loading and handling procedures, and extended quality control.

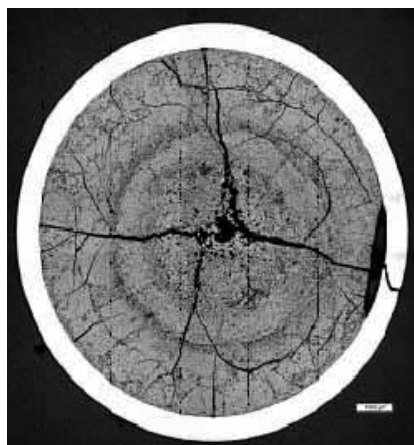
More recently, at the LaSalle and Quad Cities reactors, several fuel rod failures were attributed to the primary failure mechanism of stress corrosion cracking from pellet clad interaction (PCI), exacerbated by the presence of missing pellet surface. The resultant stress intensity concentration factor associated with the missing pellet surface condition, coupled with large power changes and power recovery ramps during/following sequence exchanges in the presence of relatively high concentrations of fission product inventory at the inner surface of the cladding, created the combination of conditions necessary to produce these failures. Indeed, during manoeuvring of the control blades, the location of failures was subject to power ramping, although the magnitude of the ramp was well within expected limits required to prevent PCI failure. Therefore, the missing pellet surface appears to have increased local stress levels and contributed to the failure [5.67].

FIG. 5.36. PCI failure due to missing pellet surface [5.67].

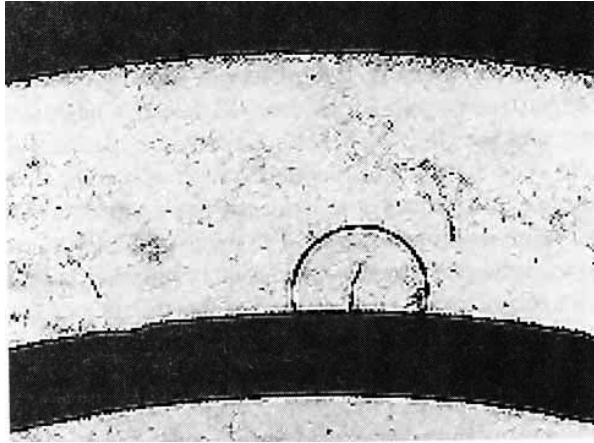
In 1992, a weld defect type not previously recognized was experienced and identified by GE [5.94]. The weld defect type is known as grain boundary separation and is characterized by a microscopic crack-like defect initiated at the weld inner surface and extending radially along prior beta grain boundaries. This defect results from the application of tensile stresses in the weld during the cool down phase of weld operation. Figure 5.43 shows a representative grain boundary separation defect [5.94]. Corrective actions taken by GE include: (1) modification of weld station hardware and processes to minimize the extent and effect of applied tensile stresses, and (2) development and implementation of extended ultrasonic capability for 100% inspection of end plug welds for grain boundary separation.

FIG. 5.43. Typical grain boundary separation (GBS) defect [5.94].

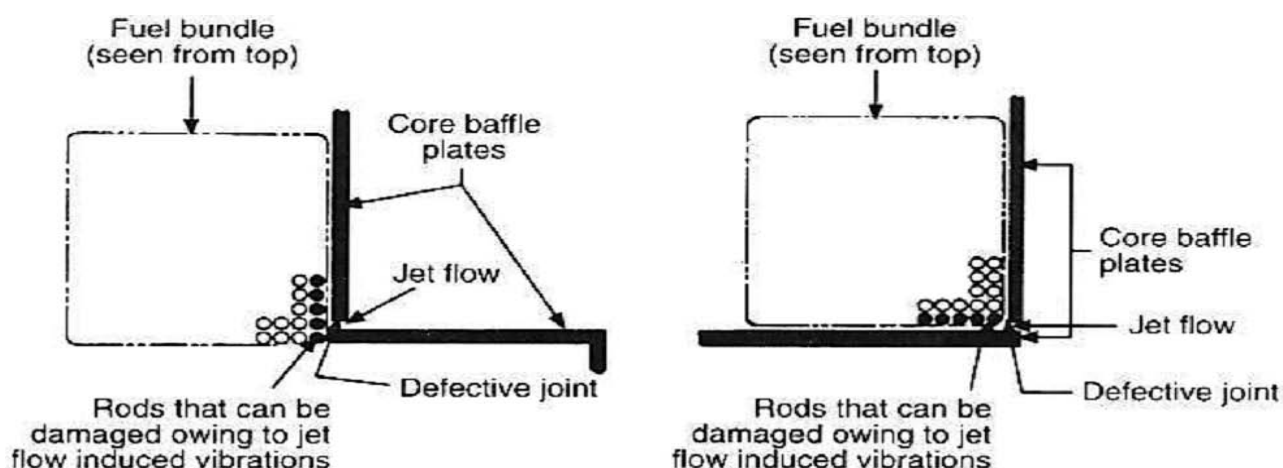
FIG. 5.45. Cross-section view of fuel bundles and baffle plates showing how gaps may open in the baffle plate joints [5.99].

Figure 5.45 [5.99] shows two ways in which the joint between two core baffle plates can open and allow a high pressure jet of water to impinge on some of the fuel rods. Such gaps are caused by stress in the baffle plate assembly during reactor operation, and may occur at any point on the joint. When such a gap occurs, coolant will rush through it because of the pressure difference across the juncture. The direction of the jet will be transverse to the fuel rods and the resulting flow will be turbulent. It will be composed of localized velocity and pressure fluctuations occurring over a wide range of frequencies. The transverse flow can produce vortices which are shed in an alternating fashion. The alternating shedding of vortices creates a fluctuation force on the fuel rod cladding. The unsteady force has components both in the direction of flow and perpendicular to this direction, i.e. drag force and lift force. When the frequency of vortex shedding equals the natural frequency of the fuel rod, or half that frequency, or any multiple of it, the structure goes into resonance and fails. This phenomenon induces severe rod damage.

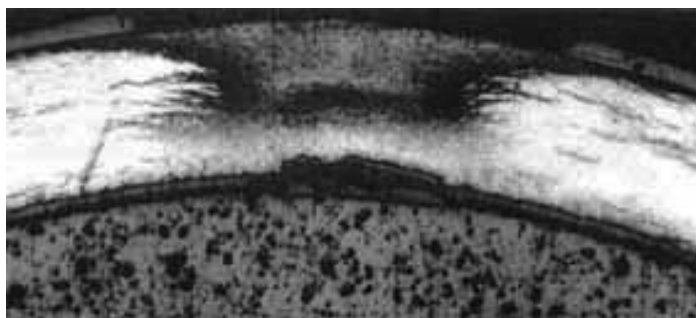
FIG. 5.46. Typical sunburst failure.

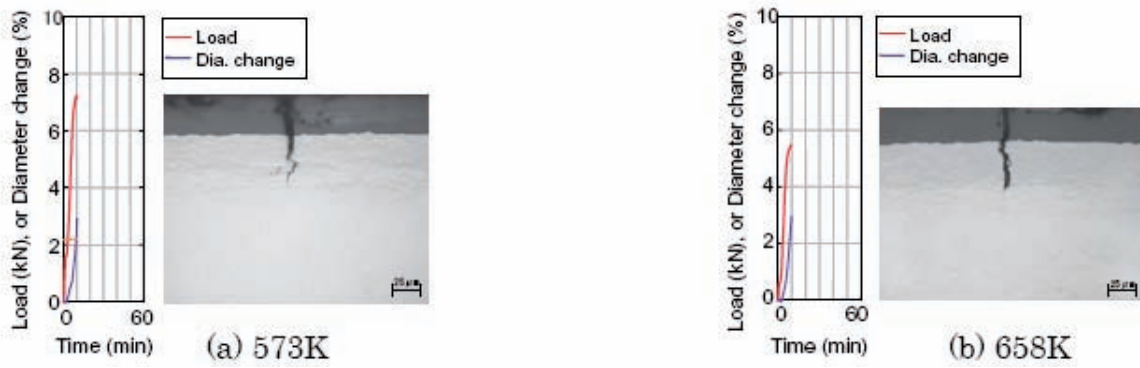
FIG. 5.52. Incipient crack formation through an EDC crack propagation test with no holding period.

The crack propagation behaviour of a PWR cladding tube was examined using an expanding mandrel test (EDC test) at temperatures of 573 K and 658 K, with consideration for the differences in BWR and PWR conditions. In order to confirm incipient crack formation, a test specimen was expanded up to about 2% circumferential strain and subjected to metallographic observation. Results are shown in Fig. 5.52. Several incipient cracks were seen in the region of concentrated hydrides at the cladding outer rim on both specimens tested at 573 K and 658 K.

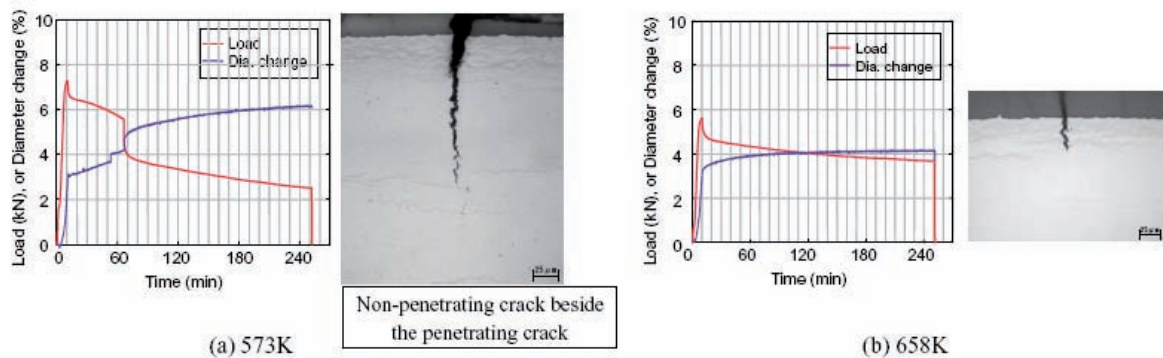
FIG. 5.53. Typical cracks after an EDC crack propagation test with a holding time of four hours.

Propagation behaviour of such incipient cracks was examined by holding the expanding device (i.e. keeping the mandrel push rod location at a specified point) for four hours after applying the loading — up to about 2% of circumferential strain. Results are shown in Fig. 5.53. A load curve for the expanding device (push rod) vs. time at 573 K showed a stepwise decrease after about 60 minutes during the holding time, suggesting cracking of a specimen. Metallography after holding for four hours revealed a penetrating crack and several non-penetrating cracks which were deeper than the incipient one. Alternatively, no abnormal change in the load–time curve was seen in the test at 658 K. Crack depth observed by metallography after four hours holding at 658 K was comparable to that for incipient cracks, showing no indication of propagation.

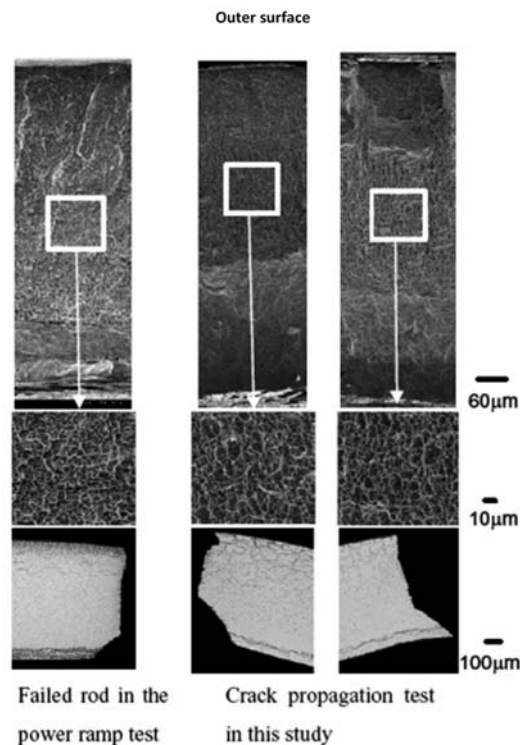
FIG. 5.54. Fractographs of specimens fractured in a brittle manner by crack propagation test.

Figure 5.54 compares fracture surfaces in the middle portion of the thickness between cladding specimens fractured in stepwise pressurization and power ramp tests. Fractographic observations suggest a crack initiation and propagation processes. The brittle surface at the outer rim may be caused by a fracture of radial hydride precipitated at the outer rim. Hydride precipitates appear in a network of circumferential and radial orientations around the cladding outer region. Although the stresses which initiated outer surface cracking were comparable to hoop strength measured in the internal pressurizing burst test, they might potentially be lowered by more concentrated radial hydride precipitates at the outer rim. A mixture of ductile and brittle surfaces can be formed during crack propagation through repetition of small hydride precipitation at the crack tip and its fracture. Since the crack propagation tests were conducted in the atmospheric environment, the hydrogen required to form hydrides at the crack tip should be supplied by stress induced diffusion from circumferences of the crack tip. The roughly estimated stress intensity factor and crack growth length were seen to be equivalent to those for delayed hydride cracking (DHC) [5.128, 5.129].

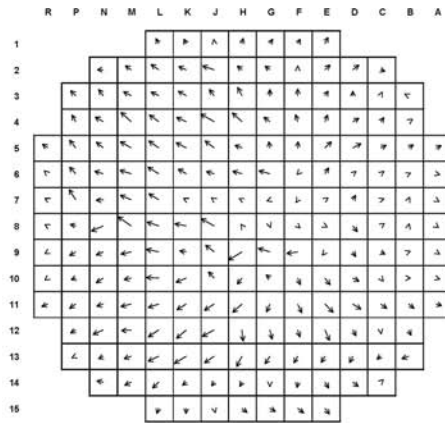
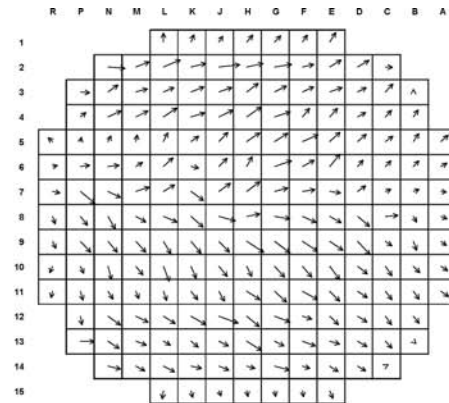
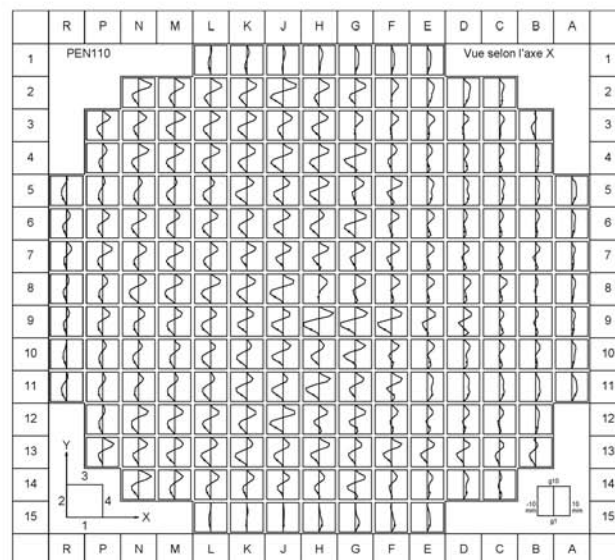
FIG. 6.2. Typical assembly bow in EDF 1300 MW(e) reactors [6.3].

A specific device was developed by EDF for FA bow measurement based on the use of an ultrasonic signal to measure the distance between fixed transducers and FA hang-up grids to the bridge in the spent fuel pit. During core unloading, each fuel assembly is stopped in front of the control process where FA bow is recorded in two directions. This recording device allows for on-line measurement of all core FAs during offload. A large database has been acquired using this device. These measurements performed on different reactors show differences in FA behaviour between 4-loop reactors and 3-loop reactors. Figure 6.2, extracted from Ref. [6.3], provides a typical FA bow at grid levels three and seven for a 4-loop reactor.

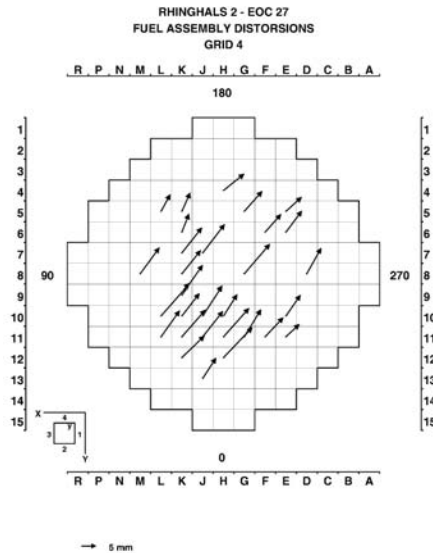
FIG. 6.3. Typical assembly bow in Ringhals reactors [6.5].

A similar collective bow pattern was found on Ringhals reactors and EDF 900 MW(e) reactors [6.5] — Fig. 6.3.

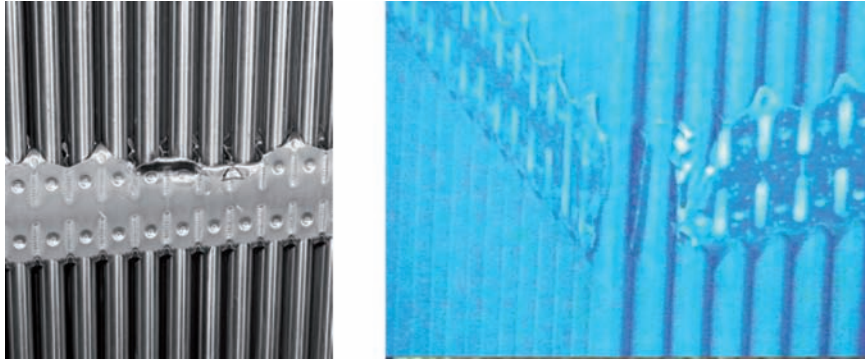
FIG. 6.13. Examples of spacer grid damage [6.14].

Statistical data show an increase in FA damage in EDF plants over the past three years, especially for 1300 MWe units. Some examples of such grid damage are illustrated in Fig. 6.13. The cause of this increase can be explained by the mechanical behaviour of the FA structure under irradiation, and particularly significant bow and unexpected grid growth (recrystallized zircaloy-4), in addition to some inappropriate handling machine settings and operating modes [6.14].

A new version of the existing AFA 3G spacer grid, with implementation of design adjustments to further increase fuel assembly in-reactor straightness and to reduce the risk of hang-ups with neighbouring fuel assemblies during loading/unloading operations is being designed by AREVA (Fig. 6.14). The main modifications to the grid have to do with the external strap (vane shape and strap welding geometry).

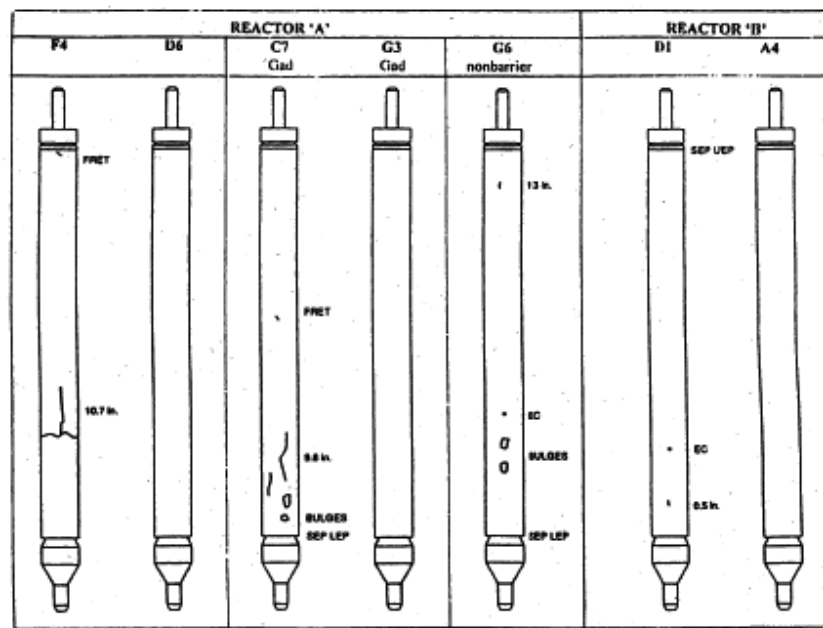
In a combined paper with EPRI, Anatech and GE [7.5], hot cell examination results for seven rods were reported, highlighting three failed and three non-failed barrier rods, and one failed non-barrier rod. The failure distribution is shown in Fig. 7.1. Two of the failed barrier rods were degraded to axial splits with fuel washout. The

FIG. 7.1. GE failed fuel rods and symmetric sound rods examined in hot cells [7.5].

primary failure cause of the non-barrier rod and the non-degraded barrier rod was PCI. The other two rods had failed due to debris fretting.

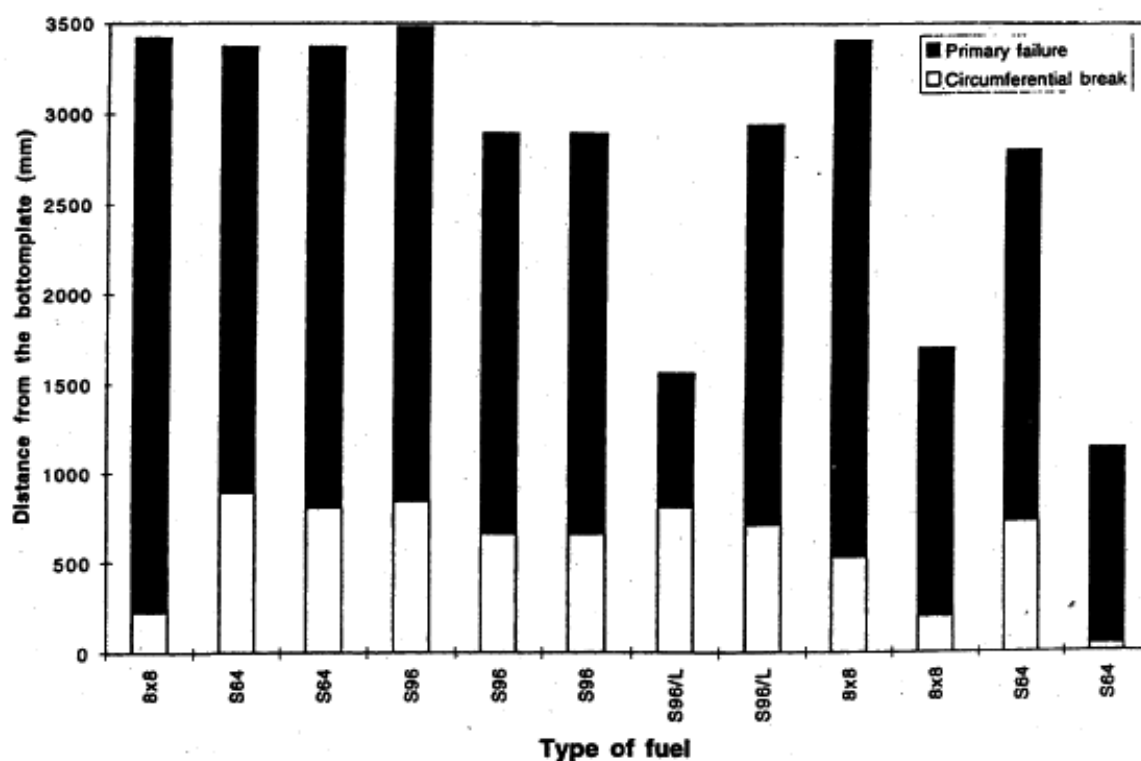
FIG. 7.2. Locations of primary failures and circumferential breaks on fuel rods for ABB SVEA fuel [7.7].

A total of 18 failed rods were examined by ABB in hot cells [7.6, 7.7, 7.9]. Secondary hydrides and primary PCI cracks have functioned as incipience for crack propagation to axial splits. The very long split in the failed sponge Zr liner rod was attributed to large tensile hoop stresses in the cladding from rapid and extensive oxidation of the liner, thus promoting crack propagation. The circumferential fractures were a consequence of massive local pick-up of hydrogen and mainly occurred at low burnup, presumably due to the open pellet clad gap leading to good steam communication. The absence of severe degradation at high burnup was attributed to the closed pellet clad gap. Circumferential fractures occurred in the bottom part of the rod with primary fretting failures near the top, as is shown in Fig. 7.2.

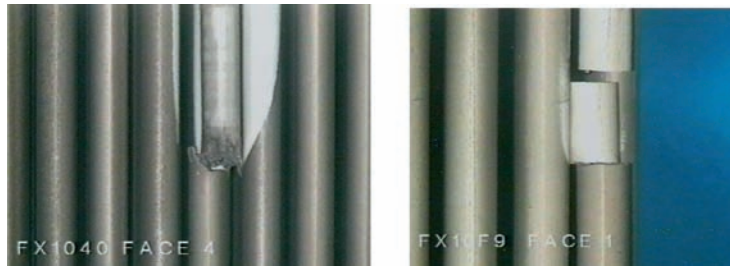
FIG. 7.4. Example of circumferential (left) or 'guillotine' (right) break.

For PWRs, secondary hydriding damage through a circumferential crack as shown in Fig. 7.4 has also been observed, especially in high burnup fuel rods.

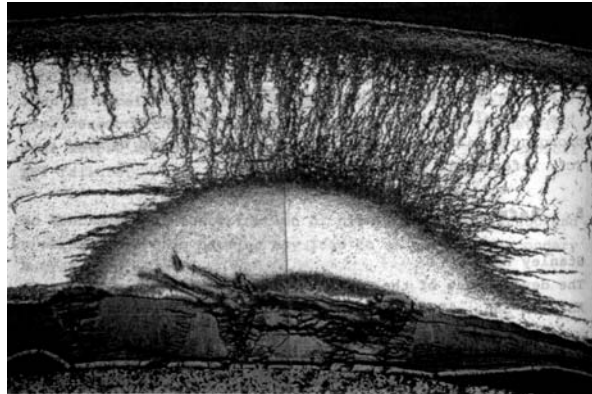
FIG. 7.5. Massively hydrided region with hydride sunburst [7.21].

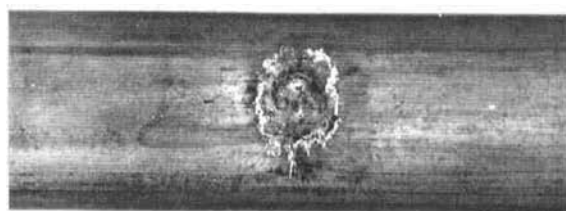
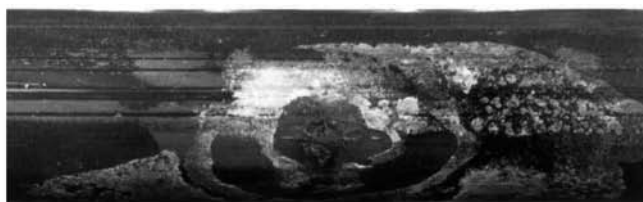
*FIG. 7.6. Sunburst.*

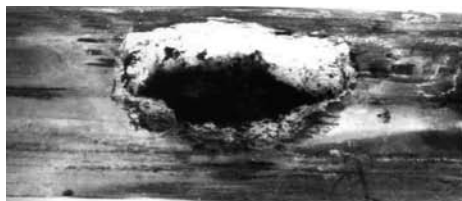
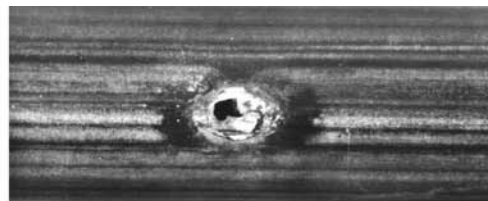
*FIG. 7.8. Holes.*

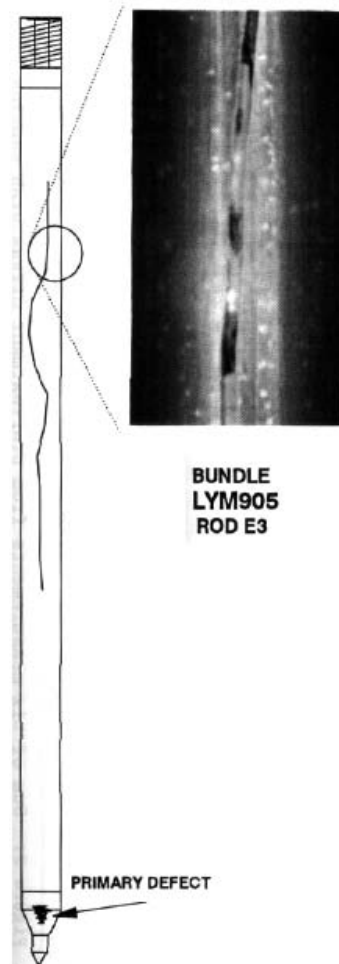
FIG. 7.10. Schematic and poolside visual of an axial split from a Hatch-2 reactor [7.22].

Deterioration of a fuel rod beyond the previous stages can lead to two specific forms of severe degradation. One form is axial split, an example of which is shown in Fig. 7.10 in a BWR fuel rod. Axial splits can form either by extension of a primary defect (called a 'propagating primary') or by initiation and growth from a secondary hydride. The path chosen depends on the acuity of the defect, stress distribution along the rod and the local environment inside the fuel rod. Propagating primary splits are particularly interesting because the splits form (by definition) in an oxidizing environment away from any massive hydriding.

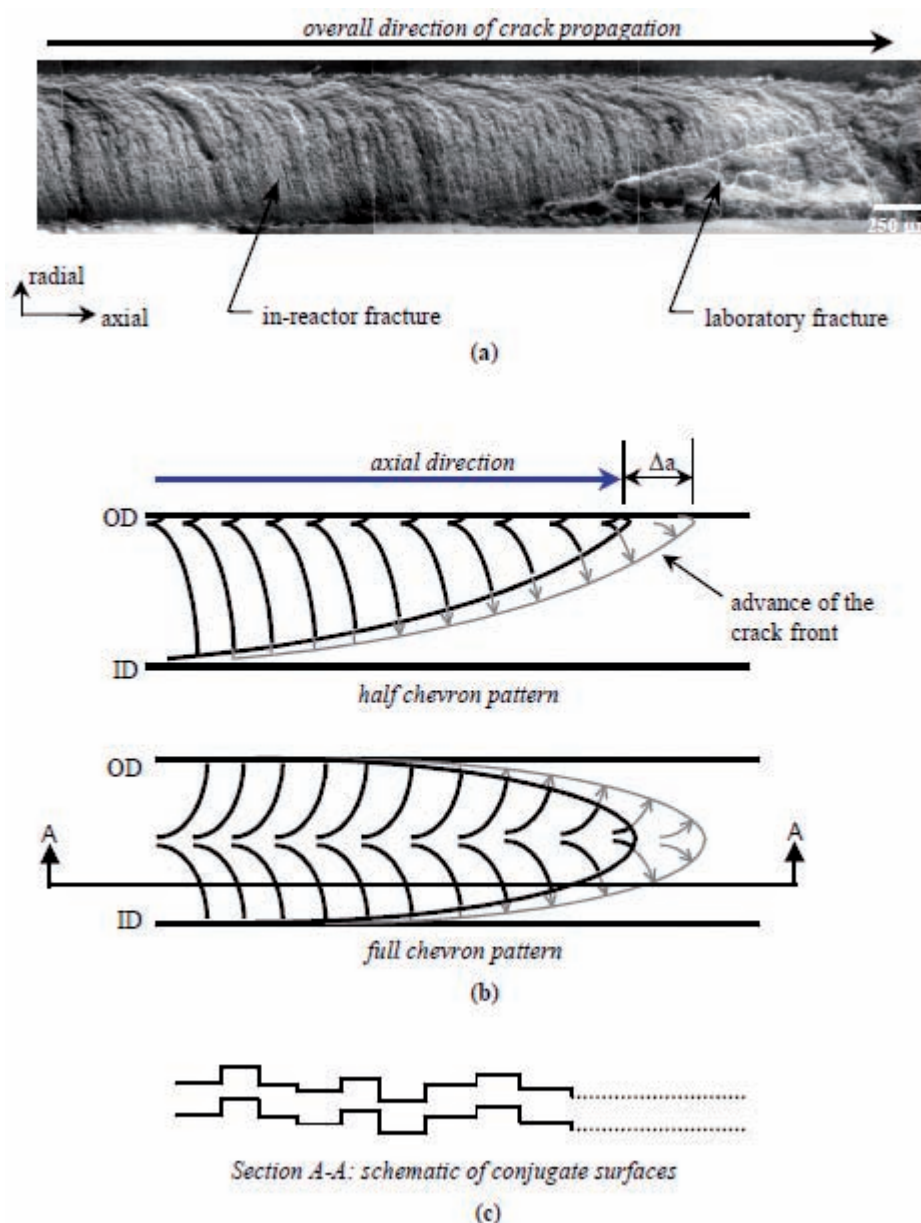
The curved, periodic markings (wrongly called ‘striations’ by some) have been found on all splits reported to date and are a key identifying feature of the crack mechanism. More recent fractography by GE at Vallecitos on well preserved split fracture surfaces has indicated that curved features are always perpendicular to the crack front and are more accurately described as chevron patterns [7.27]. These findings have since been confirmed by an examination at Studsvik [7.25]. As shown in Fig. 7.14, chevron patterns (or half chevron patterns, when a crack leads close to the outer surface) define local crack advance through the varying micro-structural features encountered along the crack tip. A cross-section of the crack, shown schematically in Fig. 7-14c, shows that chevron patterns are roughly square channels with a brittle fracture along surfaces in the fracture plane and a ductile fracture along vertical surfaces connecting the channels [7.25, 7.27].

FIG. 7.14. (a) SEM fractography of a crack tip in better preserved splits with schematics of crack fracture patterns in (b) and (c) [7.25, 7.27].

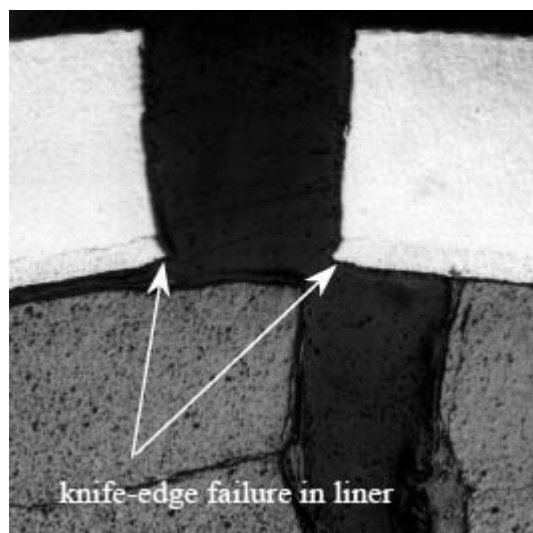
Overall, the fractures are quite brittle and radial through the cladding. As shown in Fig. 7.15, the only significant ductility is at the inner surface. In this case, the barrier exhibits a knife edge failure. More recent work by Studsvik has shown that non-barrier cladding also exhibits some ductility (measurable as wall thinning) at the inner surface [7.25].

FIG. 7.15. Transverse metallography from a split revealed a brittle failure through the matrix and ductile in the liner [7.27].

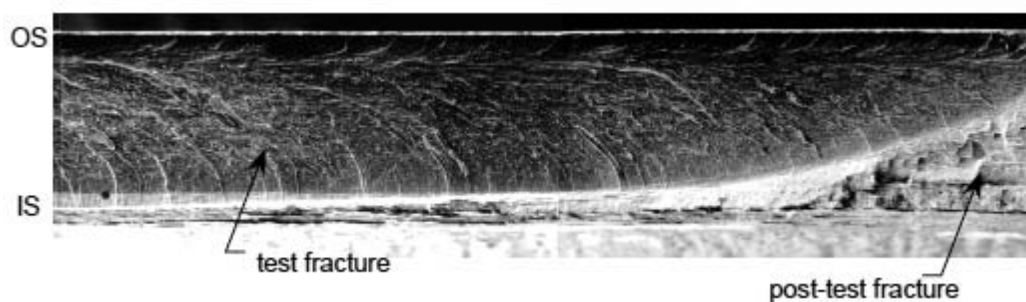
A breakthrough in degradation came from work at GE Vallecitos [7.27] on irradiated and unirradiated cladding using the split propagation laboratory investigation test (SPLIT). In these tests, a length of cladding with a central pre-crack was subjected to an internal hoop stress with a split mandrel while it underwent corrosion and hydrogen charging. In order to accelerate the corrosion reaction at the 300°C test temperature to in-reactor rates (on the inner surface (IS) of a failed fuel rod), lithium hydroxide was added to the water. The cracks that resulted were exact matches to the splits in degraded cladding in every detail. One such example is shown in Fig. 7.17.

FIG. 7.17. Fractography from SPLIT test [7.27].

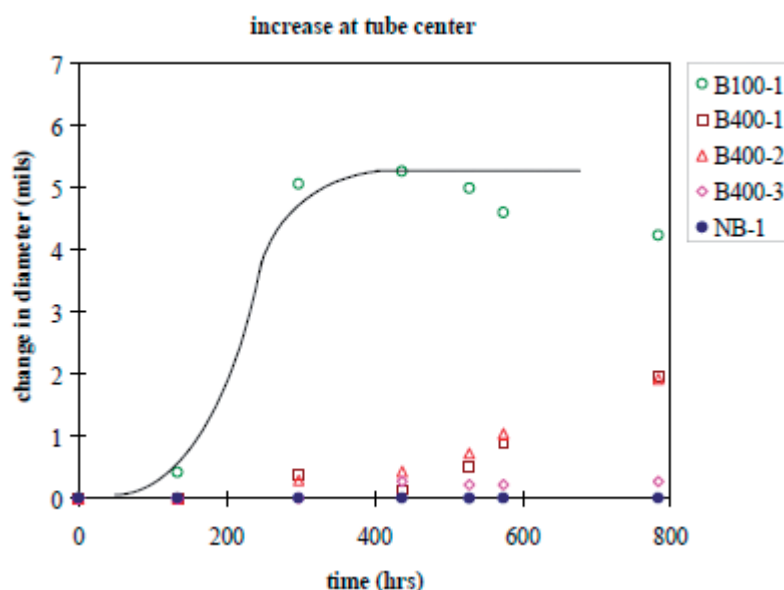
In these tests, different types of cladding were loaded with tight fitting  $\text{UO}_2$  pellets ( $\sim 75 \mu\text{m}$  initial diametral gap) and corroded in  $400^\circ\text{C}$  steam. The specimens were recrystallized tubing with two low iron zirconium barriers (100 and 400 ppm) and one non-barrier. The results are shown in Fig. 7.20. The largest effect was observed for the 100 ppm Fe barrier specimen, which was visibly deformed by corrosion. In this specimen, the entire barrier was consumed in less than 300 hours. The effect on 400 ppm Fe barrier specimens was much smaller, but still significant on two of the three lots of tubing. The non-barrier specimen never did develop pellet–cladding contact and the pellets fell out after the test. Post-test metallography of the 100 ppm Fe specimen indicated the oxide was only 60% of theoretical density. This may well be the key to oxide imposed cladding stress (i.e. an oxide porous enough to allow continued transport of steam and dense enough to support cladding stress).

FIG. 7.20. Net increase in tubing diameter for barrier cladding with 100 ppm Fe ("B100"), 400 ppm Fe ("B400") and non-barrier (NB) cladding [7.49].

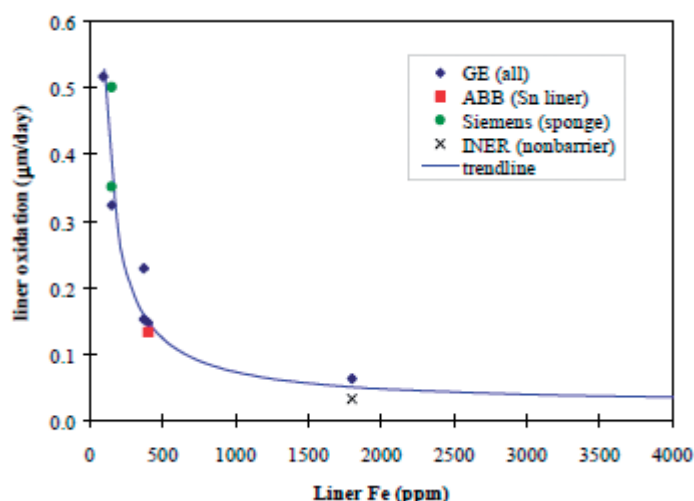
Figure 7.21 is a summary of liner oxide thickness in failed cladding as measured by PIE. The liner oxidation rates (or IS rates in the case of non-barrier cladding) were calculated from the average of all measurements published for a given rod divided by total time in a failed condition. (Note: it was not clear how to include the ABB Sn liner on a plot against iron levels, so it was arbitrarily placed at 400 ppm). While one might have anticipated considerable scatter (due to differences in the failure mode, locations of metallography specimens, etc.), the overall trend is what would be expected. The trend line is a linear regression fit to  $1/\text{Fe}$  and has no physical significance. Unfortunately, except for the one point with the ABB Sn liner, no data were available on the current generation of alloyed liners.

It appears that much of the increase in frequency and extent of damage in fuel degradation can be attributed to rapid corrosion of the unalloyed zirconium liner. This is clearly the case for long axial splits. However, depending on the specific failure, other factors have had important roles. These factors include increased ‘fuel duty’

FIG. 7.21. Summary of liner oxide thickness data from PIE results published by ABB [7.50], GE [7.51–7.54], INER [7.28] and Siemens [7.55].

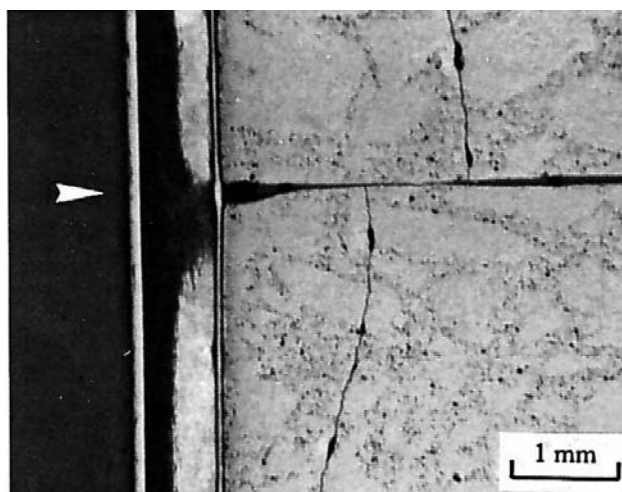
FIG. 7.22. Hydride repartition at a pellet to pellet interface [7.56].

It was shown that the high burnup rod had initially failed due to grid to rod fretting in the lower part of the rod. Examinations confirmed that secondary hydriding of the cladding was the cause of these fractures. Severe secondary hydriding of the cladding caused the formation of hydride rings at pellet to pellet interfaces, as shown in Fig. 7.22. At the pellet to pellet interface, cladding areas are typically cooler than in adjacent areas and hydride precipitates preferentially, thus forming hydride rings. The hydride causes severe embrittlement of the cladding, which when then submitted to a stress, has a tendency to break at a pellet to pellet interface.
